2 QUEMAHONING DAM

(NDI I.D.NO: 740)

PHASE I INSPECTION REPORT  
NATIONAL DAM INSPECTION PROGRAM

National Dam Inspection Program.  
Quemahoning Dam (NDI ID Number 740), Ohio  
River Basin, Quemahoning Creek, Somerset  
County, Pennsylvania. Phase I Inspection  
Report.

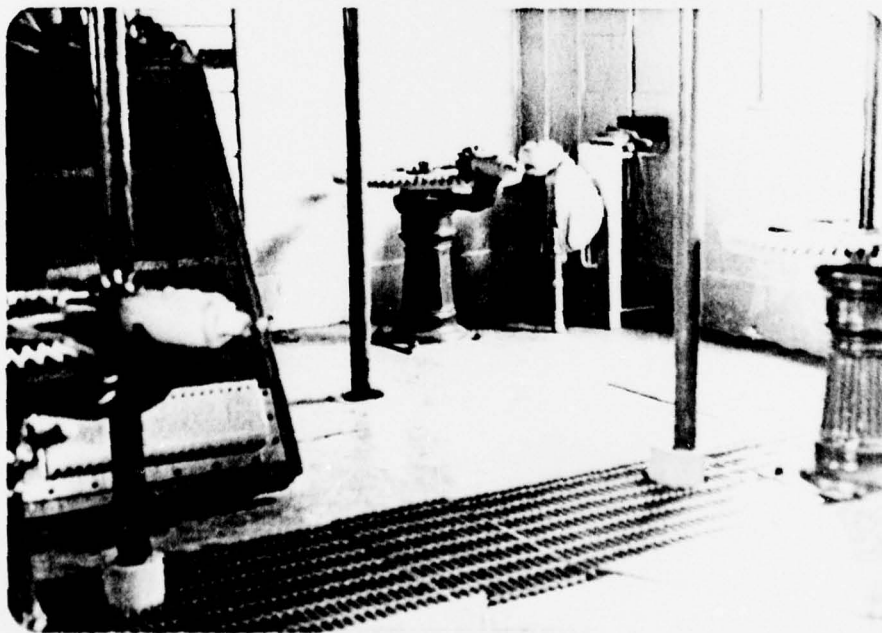
Photograph No. 6  
Valve controls in intake tower.

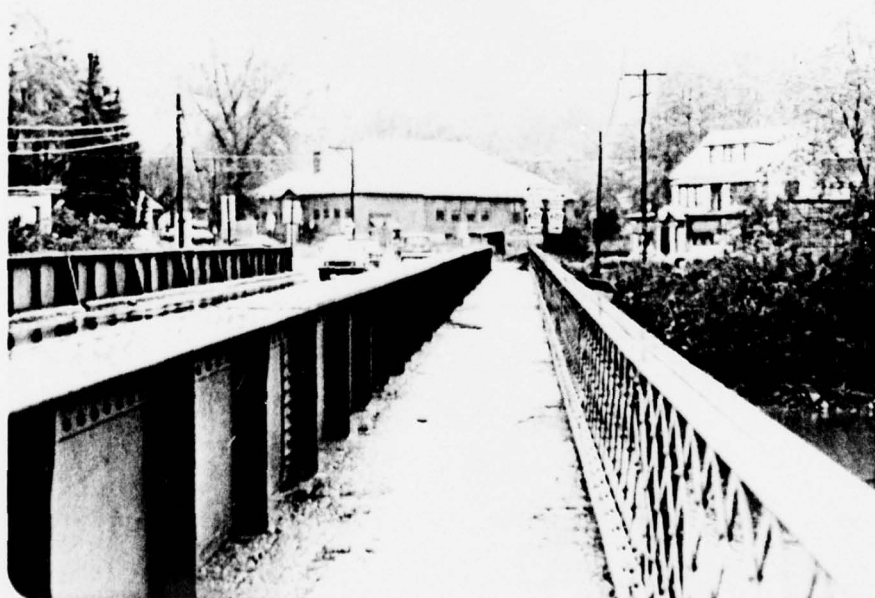
Photograph No. 14  
Bridge at Benson (looking west).
